Manhole Inspection Summary

Manhole # S43M__020MH

Insp Date: **5/18/09 8:19 AM**

Location Address: **1641 LANCASTER ST**

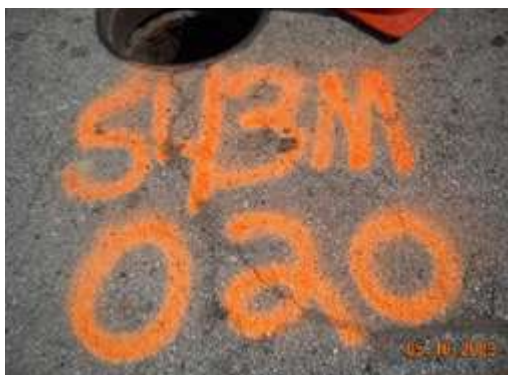
Miscellaneous

MISC. PAVEMENT MARKING

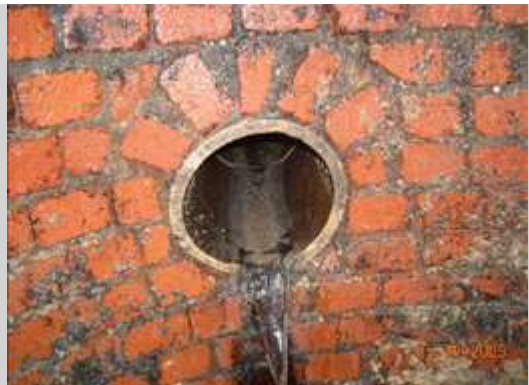
3 O'Clock Inflow

Drop In @ 3 O'Clock

Pipe Height: **12** (in.) Rod and Bar (Angled)
Pipe Material: **Clay** ☐ Pipe Lined
Invert Depth: **15.74** (ft.) Flow Characteristics: **Slow**
Deposits: ☒ None ☐ Mud ☐ Sludge ☐ Debris ☐ Grease
Silt Depth: **0** (in.) Deposits Extent:
Infiltration: **None** Pipe Seal Cond: **Sound**

Drop: **Outside** Rod and Bar
Angled: **Yes** Reading: **14.74** (ft.)
Inv Depth: **15.74** (ft.)

Drop Condition: **Clogged**

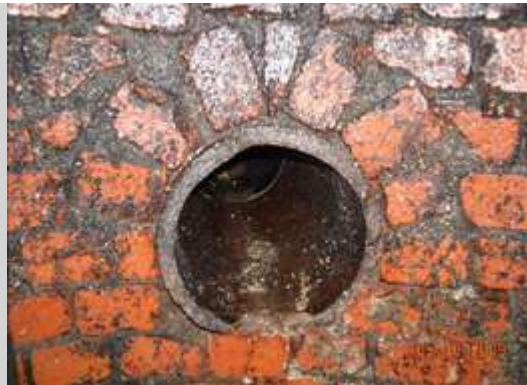
9 O'Clock Inflow

Pipe In @ 9 O'Clock

Pipe Height: **8.4** (in.) Rod and Bar (Angled)

Pipe Material: **Clay** ☐ Pipe Lined

Infiltration: **None** Pipe Seal Cond: **Sound**

Drop Condition: **Clogged**
